POPPLETON HISTORIC STUDY

B-2413

<u>Block</u>	<u>Lot</u>	<u>Address</u>
154	6-15	301-319 N. Carey Street

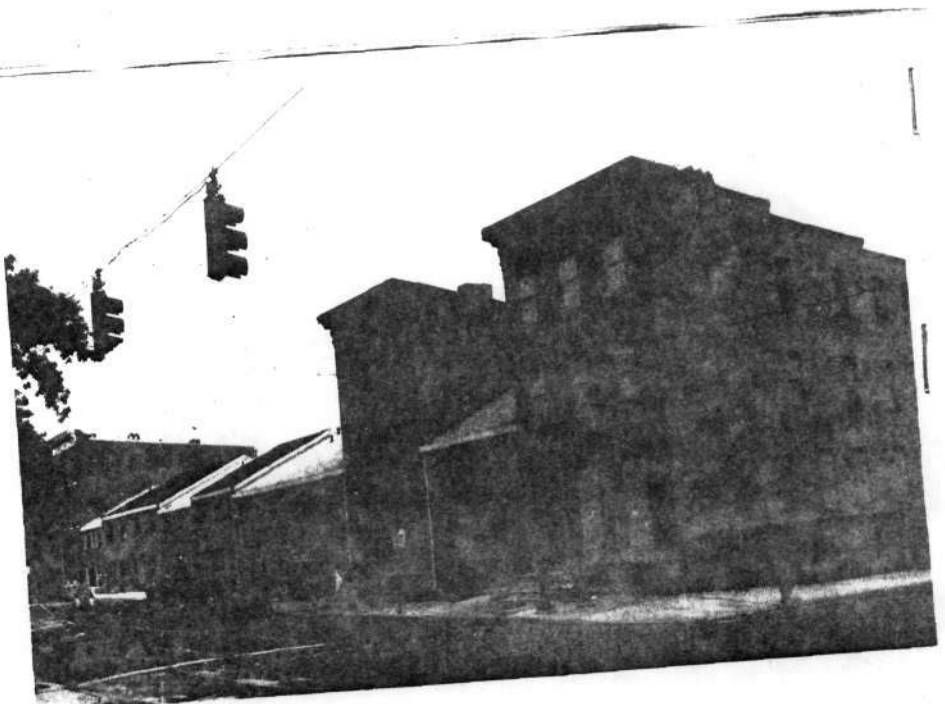
Numbers 301 and 305 give some idea of the quality of the houses which stood where the low modern houses have been built. Both are stately buildings which make the modern houses look worse than they in fact are, and in reverse, are made to look ungainly by the squat proportions of the new houses. It is an unfortunate relationship which should be remedied in this case and never again repeated. Both the old houses are vacant and at least one of them, number 307, might well be demolished and another of the meager modern ones built. The corner, number 301, might suffer the same fate except for the corner-turning effect of the tiny houses which is too awful to contemplate.

Numbers 301 and 305 are vacant. Street trees are needed. Though the visual environment has been violated, the living environment appears to be good, judging by the good maintenance and appearances.
